USACERL Technical Report N-91/29  
August 1991

1. AGENCY USE ONLY (Leave Blank)	2. REPORT DATE August 1991	3. REPORT TYPE AND DATES COVERED Final		
4. TITLE AND SUBTITLE Evaluation of Alternatives for Secondary Treatment at Central Vehicle Wash Facilities		5. FUNDING NUMBERS PE 4A162720 PR A896 TA Area B WU T10

# EVALUATION OF ALTERNATIVES FOR SECONDARY TREATMENT AT CENTRAL VEHICLE WASH FACILITIES

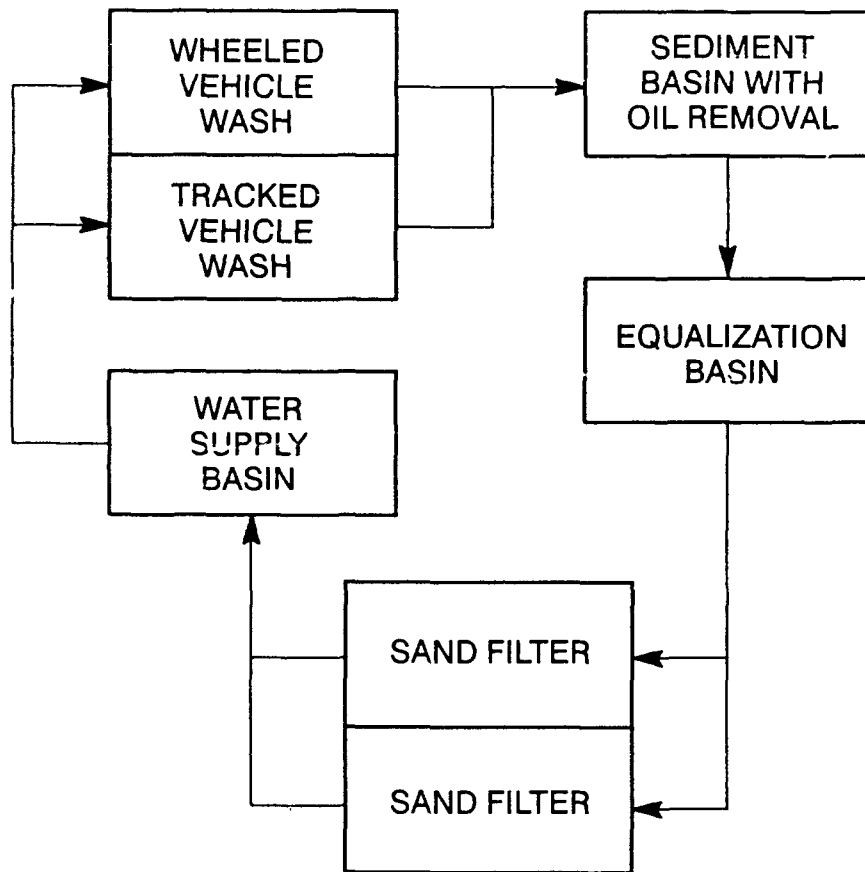
Figure 1. Flow schematic for a Fort Lewis CVWF.

Fort Lewis, WA, built the first successful CVWFs following the USACERL concept in 1980. The facilities consisted of drive-through washing stations and a recycle treatment system that used intermittent sand filtration. Figure 1 shows a flow schematic of one Fort Lewis CVWF, which is typical of the CVWF concept. In 1982, a second successful CVWF was built at Fort Polk, LA. The facility used lagoon treatment for recycling the wash water.

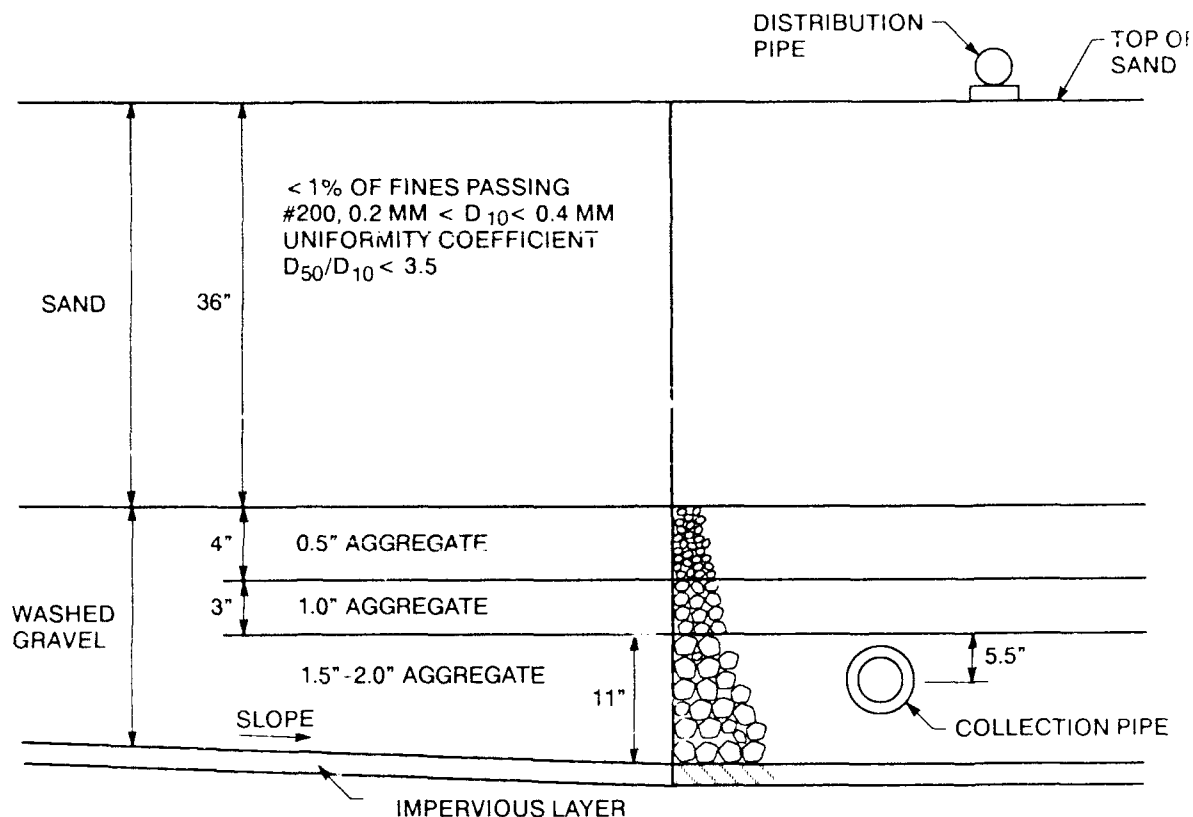
Figure 2. Media for an intermittent sand filter.

- Filter media will meet the criteria shown in Figure 2.

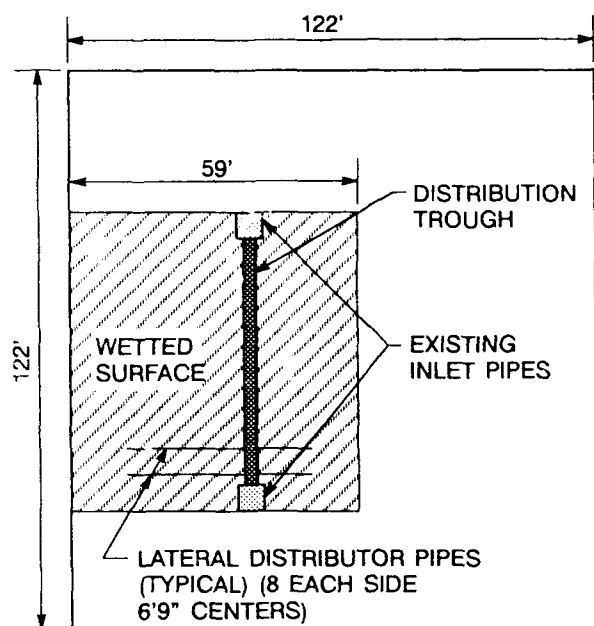
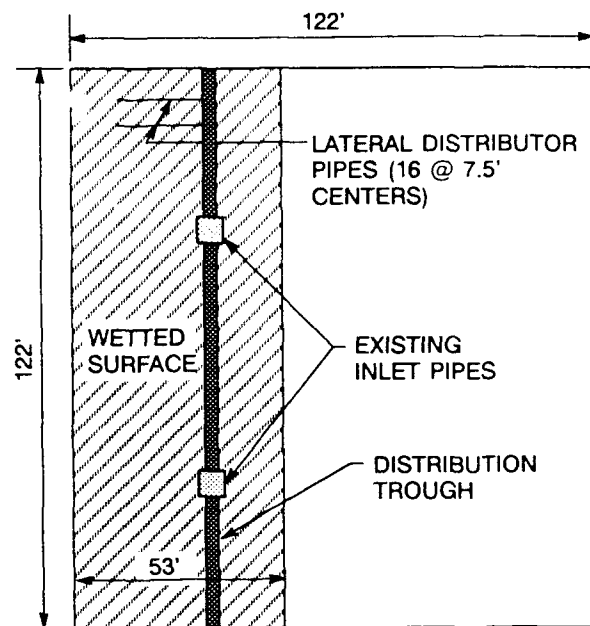
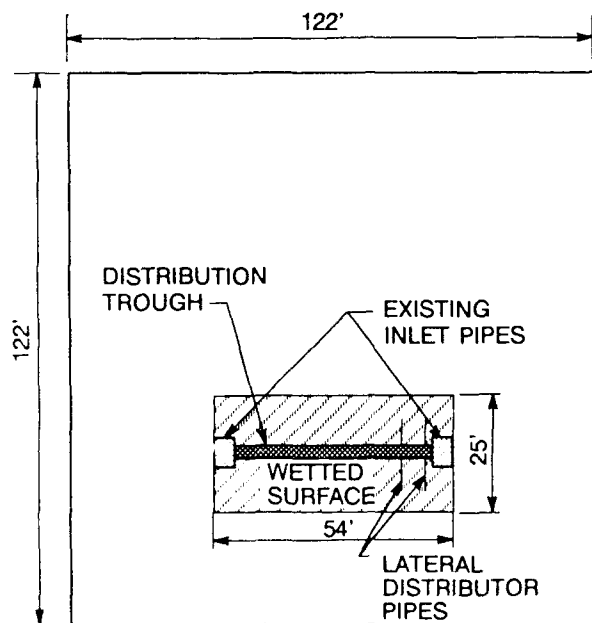
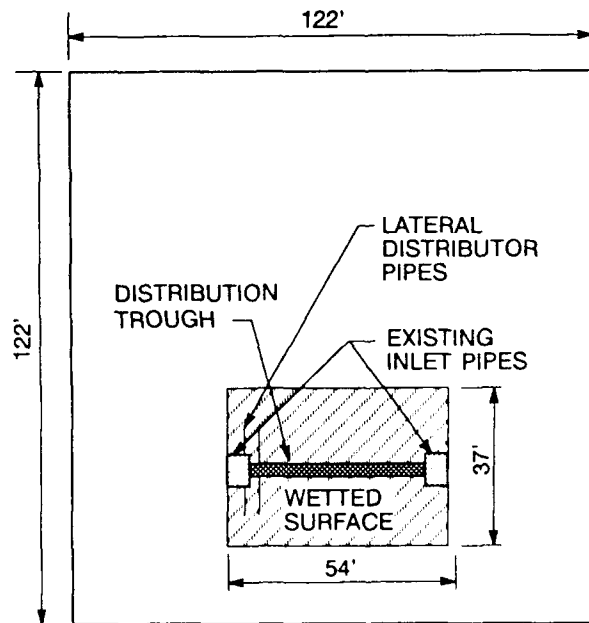
Figure 3. Partitioning of filters.

Three daily loading rates were tested at Fort Lewis: 650,000 gal/acre/day; 1,000,000 gal/acre/day; and 1,300,000 gal/acre/day. The filters at Fort Lewis were designed for a loading rate of 490,000 gal/acre/day. However, the number of vehicles washed and the amount of water needed at the Fort Lewis CVWFs is much less than predicted in the design analysis. That is why the partitioned areas used in the experiment are much smaller than the original filter surface area of 1/3 acre per filter.

FORT LEWIS SOUTHWEST CVWF  
 FILTER #2 WETTED SURFACE AREA = 3010 SQ FT  
 DAILY LOADING RATE = 1,300,000 GAL/ACRE/DAY

FORT LEWIS SOUTHWEST CVWF  
 FILTER #1 WETTED SURFACE AREA = 6020 SQ FT  
 DAILY LOADING RATE = 650,000 GAL/ACRE/DAY

FORT LEWIS SOUTHEAST CVWF  
 FILTER #2 WETTED SURFACE AREA = 1340 SQ FT  
 DAILY LOADING RATE = 1,000,000 GAL/ACRE/DAY

FORT LEWIS SOUTHEAST CVWF  
 FILTER #1 WETTED SURFACE AREA = 2010 SQ FT  
 DAILY LOADING RATE = 650,000 GAL/ACRE/DAY

Sample Location	SS Concentration (mg/L)				% Removal	
	Influent		Effluent			
	Range	Average	Range	Average	Range	Average
SW Filter 1	7-24	12	3-19	9	-90 to 75	26
SW Filter 2	7-34	17	2-22	7	-57 to 82	48
SE Filter 1	7-63	22	1-7	3	57-98	82
SE Filter 2	4-53	18	1-12	3	25-98	77

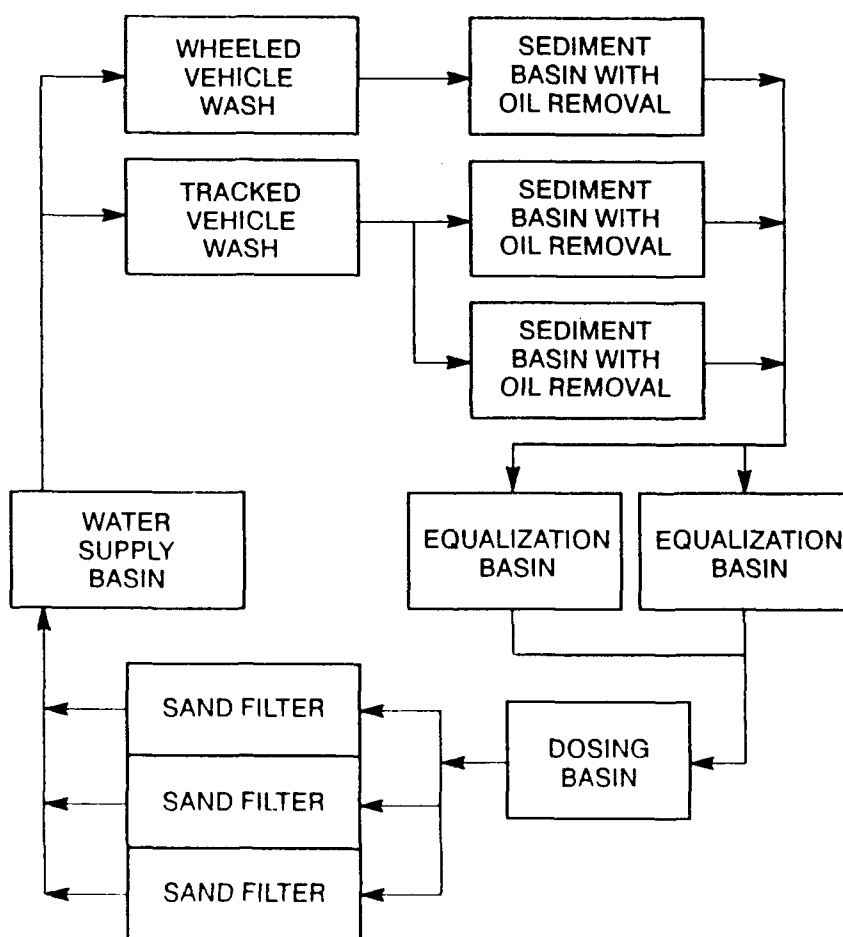
Figure 4. Flow schematic for the 2AD CVWF.

The 2nd Armored Division (2AD) CVWF at Fort Hood went on line in 1987. That CVWF has three 1.1-acre filters designed for a loading rate of 650,000 gal/acre/day. Soiling conditions at Fort Hood are much more variable than at Fort Lewis. Some parts of the training areas have very clayey soil. During wet weather, tracked vehicles carry in hundreds of pounds of cohesive soil that is difficult to remove. Water use at the 2AD CVWF appears to be much closer to what was predicted in the design analysis than it was at Fort Lewis. Figure 4 shows a schematic of the 2AD CVWF.

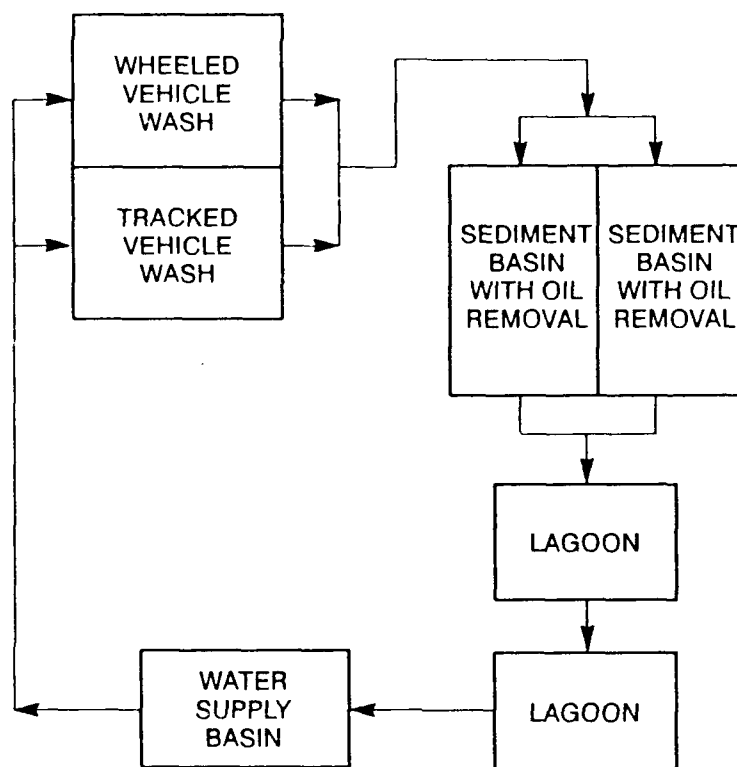
Figure 5. Flow schematic for 1st Cav CVWF.

The second large CVWF built at Fort Hood, used by the 1st Cavalry Division (1st Cav), has been in operation since February 1989. This facility uses two lagoons in series for secondary treatment in its recycle treatment system. Figure 5 shows a schematic of the 1st Cav CVWF. The vehicles washing at the facility train in the same conditions as the vehicles that wash at the Fort Hood 2AD CVWF.

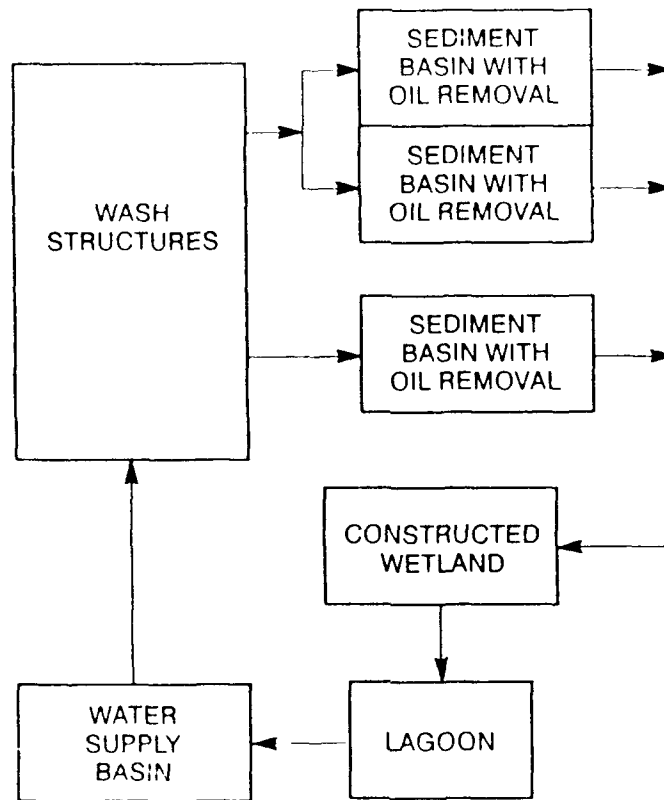
Figure 6. Flow schematic for Fort Riley CVWF.

The CVWF at Fort Riley serves a mechanized infantry division. The soils in the training area seem to be primarily silts and clays, and the soiling on the vehicles is average. The existing CVWF is a retrofit of a failed wash facility and a treatment system that had combined industrial wastewater with recycled wash water. Three of the four lagoons in the original treatment system were isolated for use only by the retrofitted wash facility. Figure 6 shows a flow schematic of the Fort Riley CVWF.
